LITTLE YOUGHIOGHENY RIVER SITE NO.3

PHASE I INSPECTION REPORT

NATIONAL DAM INSPECTION PROGRAM

11 MAY 1979

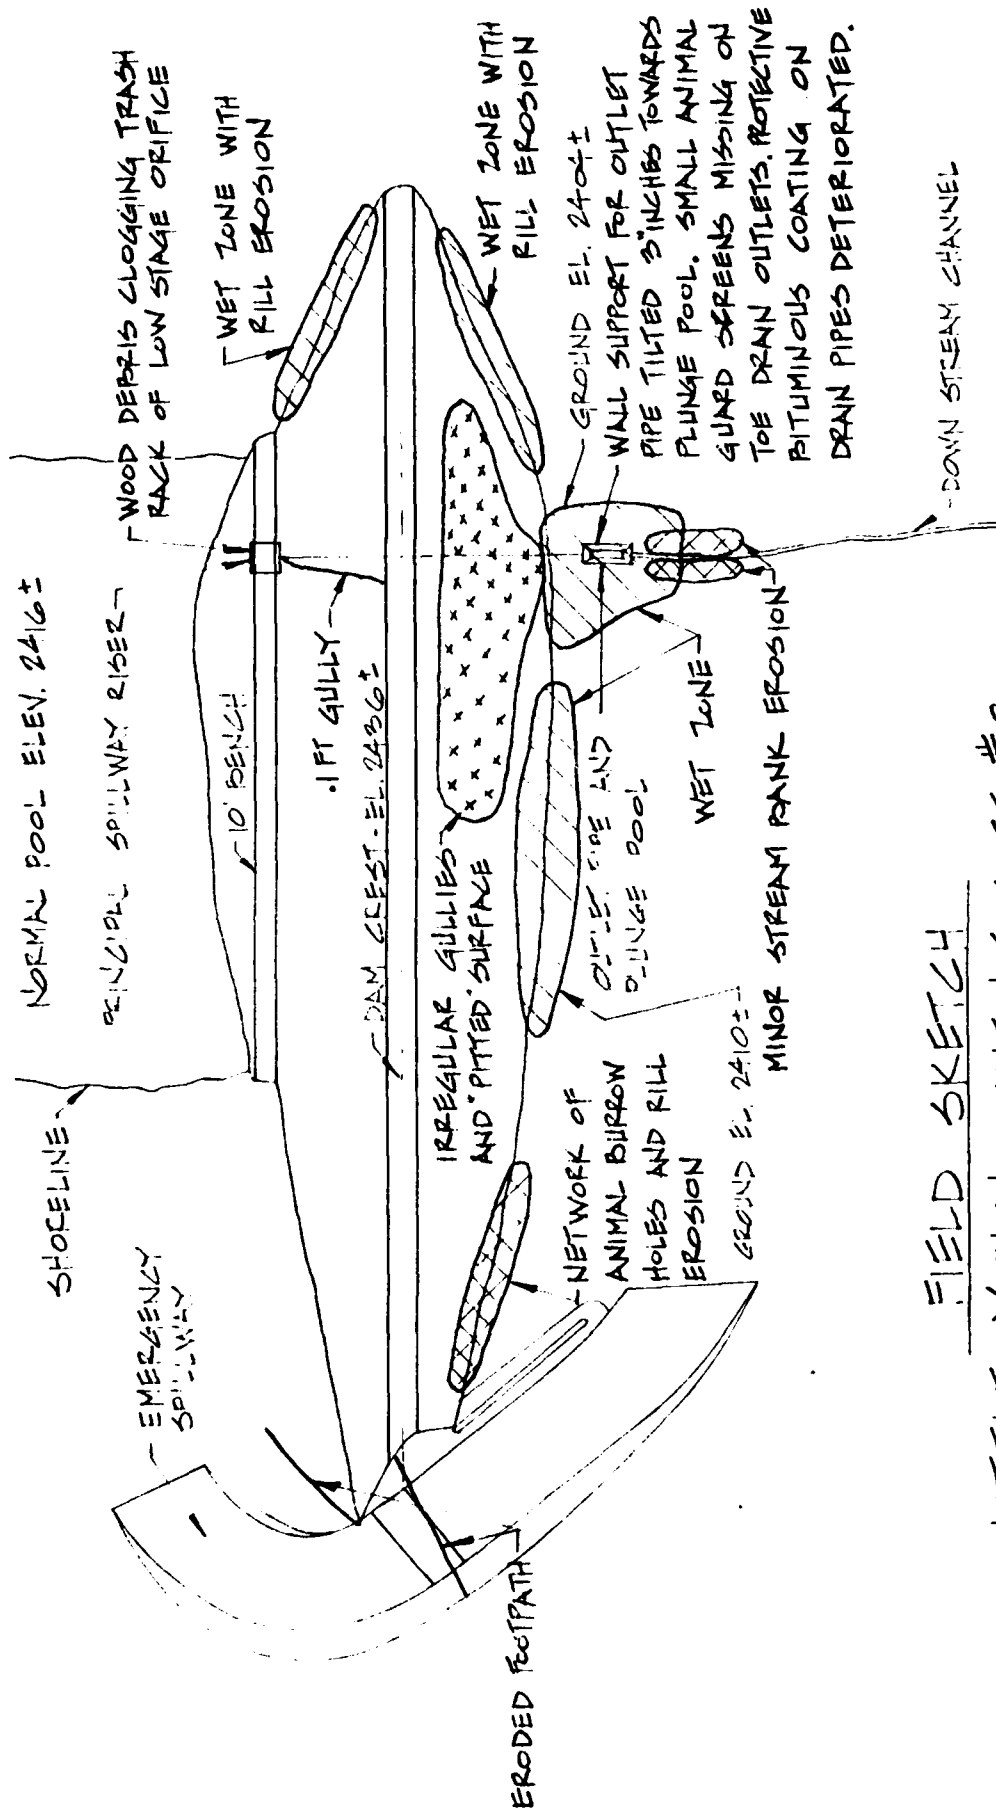
FIELD SKETCH
LITTLE YOUGHIOGENY SITE #3

- (3) Wet Zone. Wet zones were observed near the vicinity of the plunge pool and along the downstream embankment toe. (Refer to field sketch for approximate locations.) The wet zones are thoroughly saturated and very soft. These zones

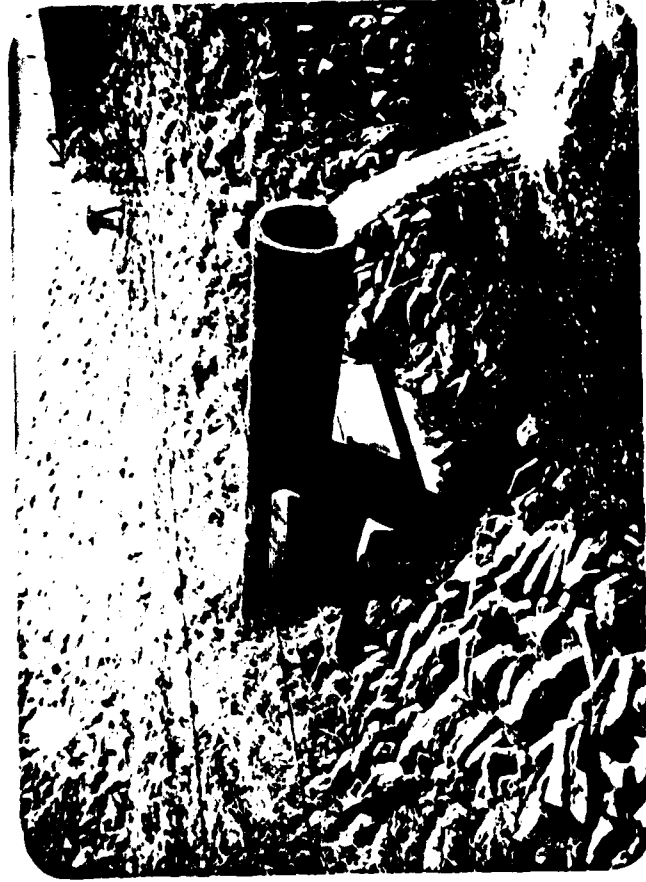
- 3) Outlet Works. A concrete wall, designed to support the outlet pipe at the location of the plunge pool, has moved outward toward the plunge pool approximately three (3) inches. This offset is evidenced by the misalignment of the concrete form break between the keyed pipe cradle and concrete wall bent. Exposed pipe and concrete cradle surfaces were observed in good condition with no spalling or cracking evident. (See Photographs 5 & 6.)

Small animal guard screens are missing from the seepage drain pipes. The protective bituminous coating on the corrugated drain pipes appears to be slowly deteriorating and has already exposed bare metal surfaces. Both drain pipes had a clear discharge at the rate of about 1 gpm.

- b. Appurtenant Structures. Continued movement of the outlet pipe support wall may open pipeline joints. In the event pipe joints open, some internal erosion of the sandy and silty clay embankment soils may occur. This erosion may become significant enough to affect the stability of the outlet pipeline. Insufficient data is available at the present time to ascertain the exact cause of the support wall movement or condition of pipe joints. An immediate inspection should be made of pipeline joints to determine if pipe joints have separated and exceed allowable tolerances. Periodic observation of the outlet pipe support wall is also advised to ascertain future movement. The general condition of the outlet pipe and wall support system is therefore considered fair.

- (3) Outlet Pipe and Support Wall. Continued movement of the outlet pipe support wall may open pipeline joints. In the event of pipe joints opening, some internal erosion of the sandy and silty clay embankment soils may occur. This suspected internal erosion may affect pipeline stability. Therefore, it is recommended an inspection be made of pipeline joints to determine if pipe joints have separated and exceed allowable tolerances. Periodic observation of the wall support system is also advised to ascertain future movement.

PHOTOGRAPH 5 View of outlet pipe, toe drain pipe and wall support system.

- 1) Inspect principal spillway outlet pipe joints. Inspection to consist of measuring pipe joint openings to check tolerance.
- 2) Monitor, by observation, wet zones located at toe of downstream embankment slope for development of seepage conditions.
- 3) Periodically observe outlet pipe wall support system for evidence of continued movement.
- 4) Develop a formal flood surveillance and warning plan.

- 5) Replace small animal guard screens on seepage outlet pipes.
- 6) Repair eroded rills, gullies, and animal burrow holes on dam embankments and abutments.
- 7) Remove wood debris from low stage trash rack.

- c. Necessity for Further Investigation. As previously stated, it is recommended an immediate inspection be made of pipeline joints. This investigation should consist of measuring pipeline joint openings to determine if movement of the outlet pipe support wall system has separated pipeline joints beyond allowable tolerances. The scope of this recommended inspection is beyond the intended scope of a Phase 1 investigation.
